Energy Audit Report for
West End Place Condominium
1099 22nd Street, NW
Washington, DC 20037

Executive Summary

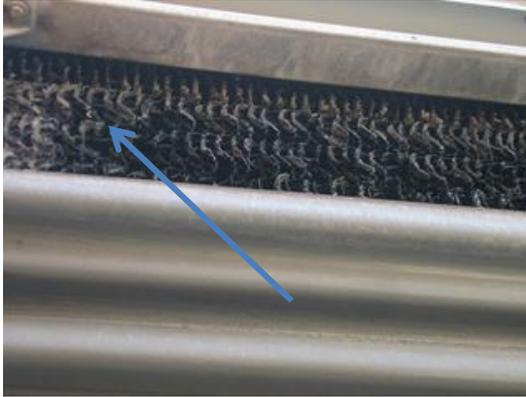
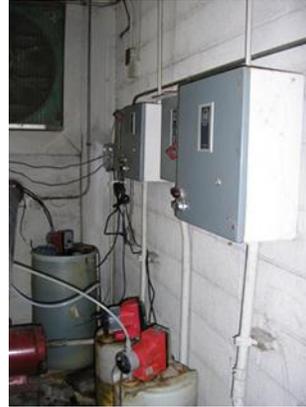
During several visits to the site, surveys of the cooling tower, heat exchanger and condenser water loop pumps in the mechanical area on the roof were conducted. The cooling tower fill is fouled at both faces of the tower. This fouling affects the efficiency of the cooling tower to reject heat and should be addressed. The tower fan and pumps were continuously running during the day that we were on site. Given that at least part of the condo owners would have been at work, load on these systems should have been minimized and the towers and pumps would be cycling.

Before any additional studies on the condenser loop components are conducted, it is recommended that the cooling tower, heat exchangers and piping loops be thoroughly cleaned and all equipment and controls be inspected and recommissioned by the HVAC contractor.

Clean cooling tower and heat exchanger

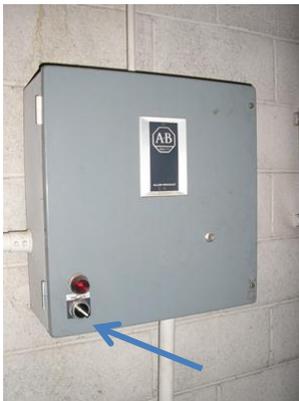
It was also observed that one of the condenser water pumps was operated on ‘Hand’. This would cause the pump to run continuously. Allen Bradley controls are installed but may not be operating.

Contract HVAC contractor to evaluate controls and recommission equipment.

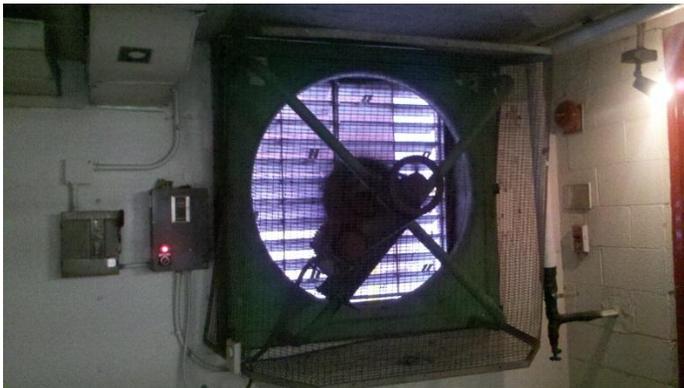
The garage exhaust fans currently run 24/7. The function of these exhaust fans is to remove car fumes, etc from the space so that carbon monoxide levels are maintained at a safe level. It is recommended that a carbon monoxide sensor control be installed to operate the exhaust fans. ASHRAE HVAC Applications handbook states that control of fans by CO level can result in 30% energy savings as compared to continuously operated fans.

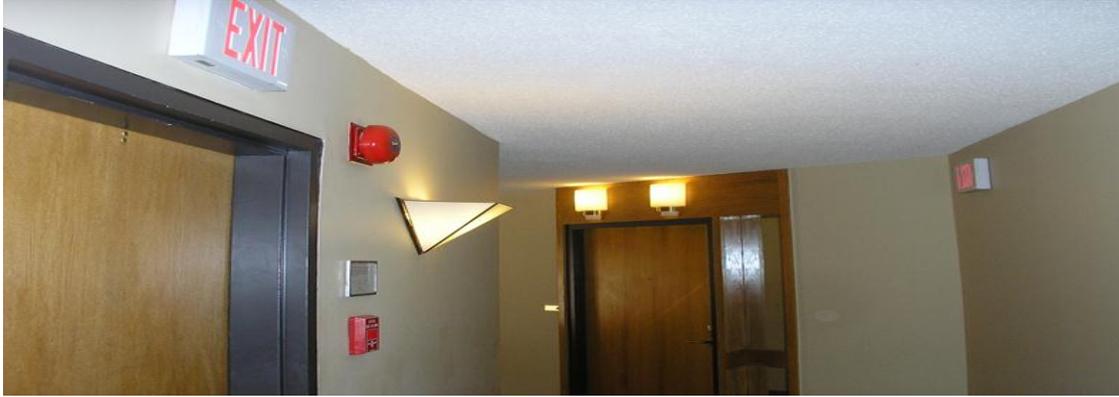
A survey of condo common area lighting and controls revealed that upgrades to CFL's have previously been implemented. Further upgrades to the interior lighting systems should include photosensors in hallways and lobbies. The light levels during the day in these areas is sufficient without additional artificial light sources. (measurements of 40 – 70 lux in hallways) Reduction of operating hours on with the current fixtures and lamps will result in energy savings with these systems.

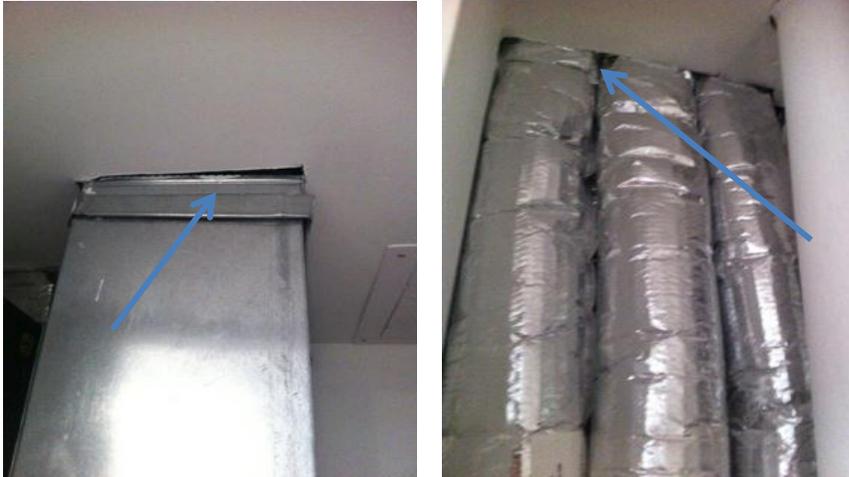
The blower door testing in one condo space revealed major leakage in the mechanical closet and around door frames. Encouraging the condo owners to inspect and seal areas around ductwork and piping in the mechanical closets will reduce this infiltration. A recommendation of sealing and insulating the steel columns in the condos is a low cost project with comfort benefits.

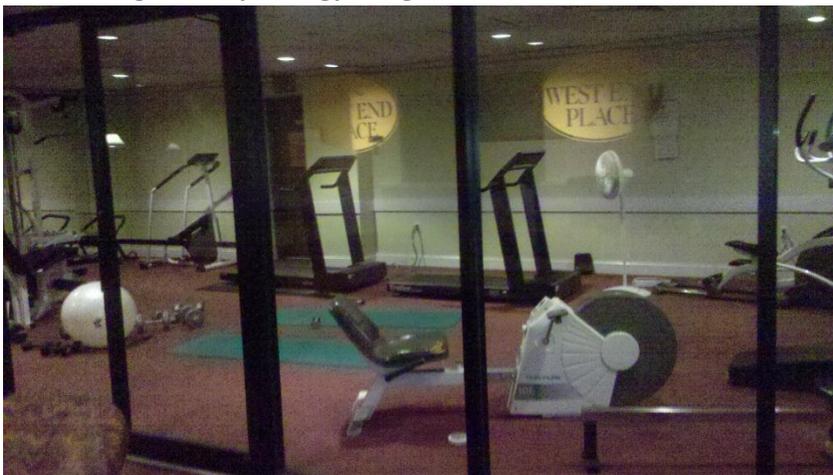
The fitness equipment is in standby 24/7. A cursory survey of the O&M manuals of the equipment did not reveal any detriment to powering down the equipment when not in use. We recommend placing the equipment on timers to reduce start up delays prior to busy use times and eliminating standby energy usage.
