**Energy Audit Report for  
West End Place Condominium  
1099 22<sup>nd</sup> Street, NW  
Washington, DC 20037**

### **Executive Summary**

The West End Place Condominium is a residential, multifamily building with 11 stories, 67 condo units encompassing 103,906 square feet. An underground parking facility for the tenants occupies 2 floors below the building. Construction of the property was completed in 1985.

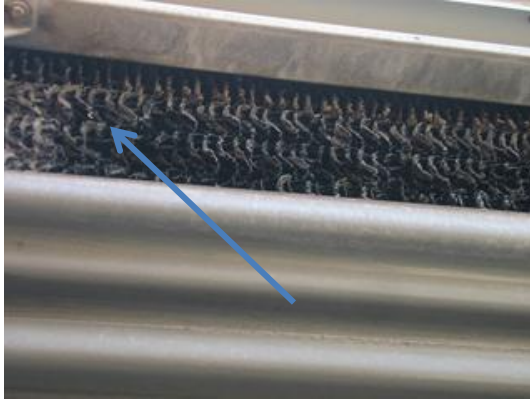
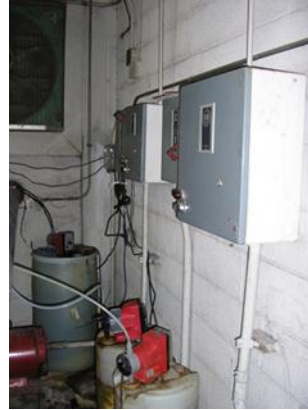
During several visits to the site, surveys of the cooling tower, heat exchanger and condenser water loop pumps in the mechanical area on the roof were conducted. The cooling tower fill is fouled at both faces of the tower. This fouling affects the efficiency of the cooling tower to reject heat and should be addressed. The tower fan and pumps were continuously running during the day that we were on site. Given that at least part of the condo owners would have been at work, load on these systems should have been minimized and the towers and pumps would be cycling.

Before any additional studies on the condenser loop components are conducted, it is recommended that the cooling tower, heat exchangers and piping loops be thoroughly cleaned and all equipment and controls be inspected and recommissioned by the HVAC contractor.

Clean cooling tower and heat exchanger

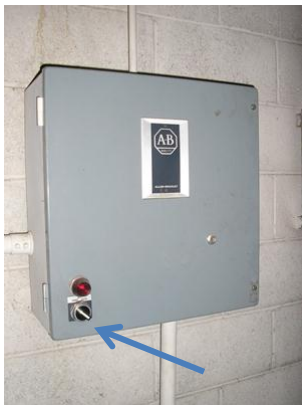
It was also observed that one of the condenser water pumps was operated on ‘Hand’. This would cause the pump to run continuously. Allen Bradley controls are installed but may not be operating.

Contract HVAC contractor to evaluate controls and recommission equipment.

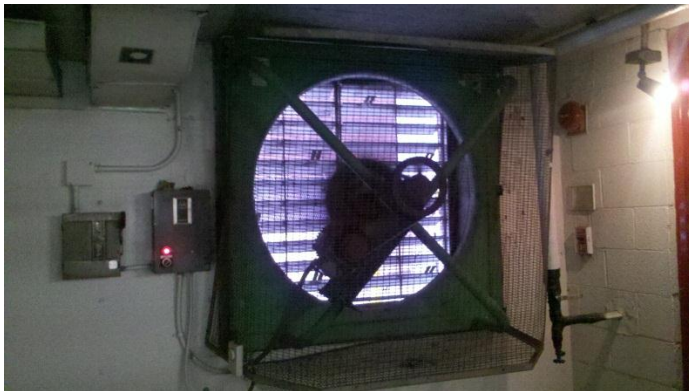
The garage exhaust fans currently run 24/7. The function of these exhaust fans is to remove car fumes, etc from the space so that carbon monoxide levels are maintained at a safe level. It is recommended that a carbon monoxide sensor control be installed to operate the exhaust fans. ASHRAE HVAC Applications handbook states that control of fans by CO level can result in 30% energy savings as compared to continuously operated fans.

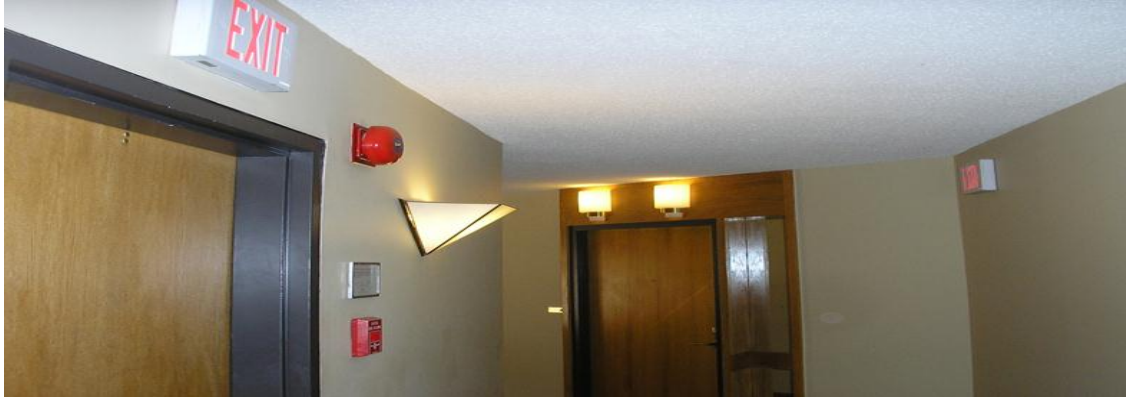
A survey of condo common area lighting and controls revealed that upgrades to CFL's have previously been implemented. Further upgrades to the interior lighting systems should include photosensors in hallways and lobbies. The light levels during the day in these areas is sufficient without additional artificial light sources. (measurements of 40 – 70 lux in hallways) Reduction of operating hours on with the current fixtures and lamps will result in energy savings with these systems.

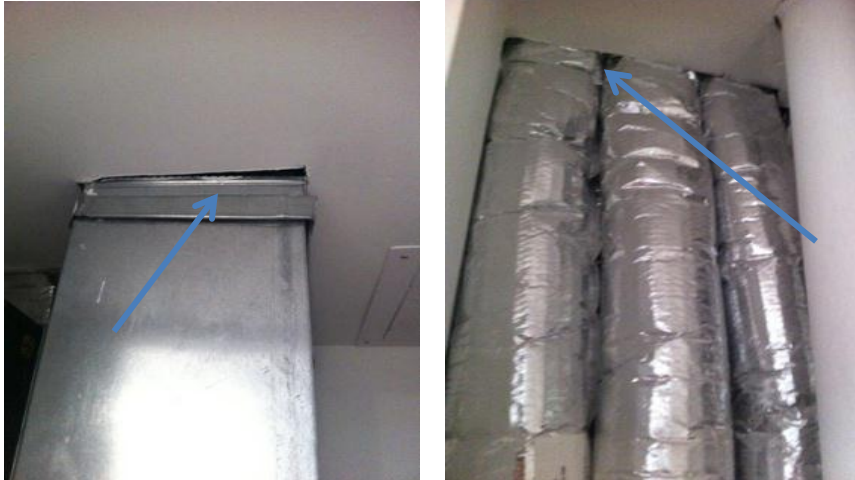
The blower door testing in one condo space revealed major leakage in the mechanical closet and around door frames. Encouraging the condo owners to inspect and seal areas around ductwork and piping in the mechanical closets will reduce this infiltration. A recommendation of sealing and insulating the steel columns in the condos is a low cost project with comfort benefits.

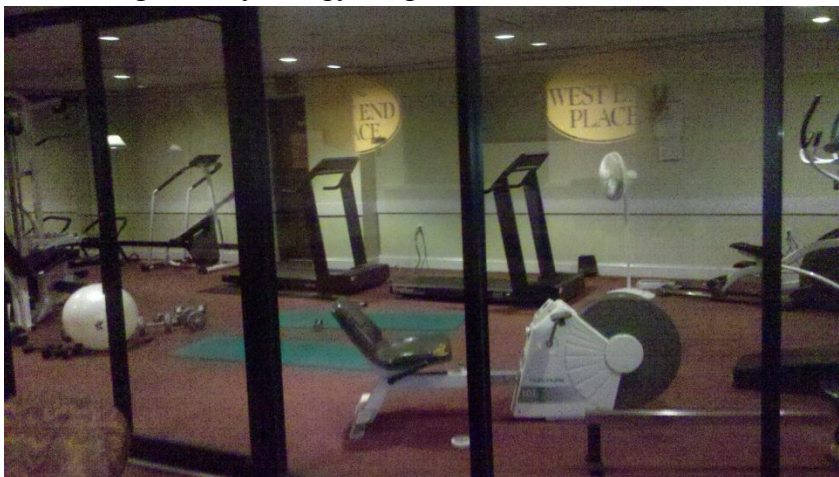
The fitness equipment is in standby 24/7. A cursory survey of the O&M manuals of the equipment did not reveal any detriment to powering down the equipment when not in use. We recommend placing the equipment on timers to reduce start up delays prior to busy use times and eliminating standby energy usage.
